# AN ASSESSMENT OF ELEPHANT MORTALITY DUE TO TRAIN HITS IN INDIA

SUBMITTED BY  
WILDLIFE TRUST OF INDIA

December 2011

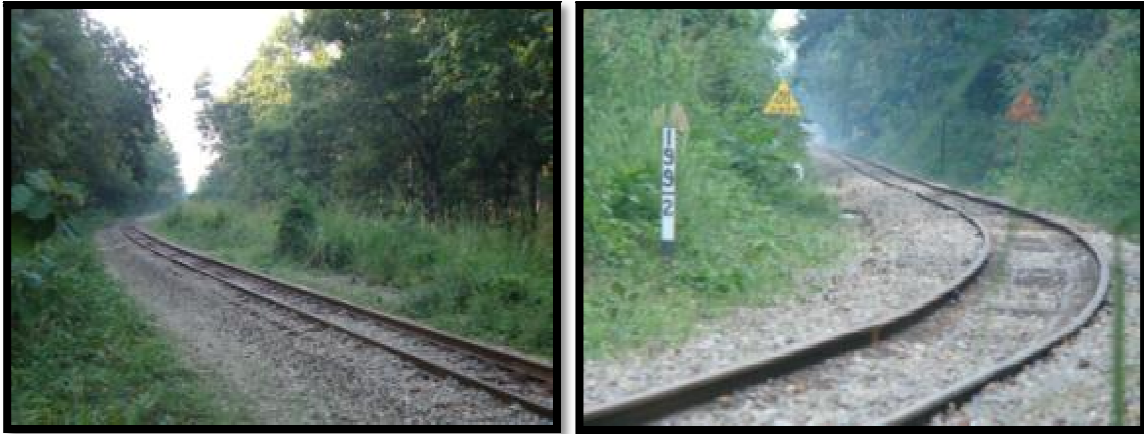
**Fig. 3.13 Critical curves in Dudhwa National Park**

In Dudhwa National Park and Katerniaghat Wildlife Sanctuary a total of 16 critical curves have been recorded (Appendix-3). It is found that the several wildlife mortalities have taken place on sharp curves. The frequency of wildlife mortality in Dudhwa National Park on curves no 22, 23, 26 and 27 to be found very high as

compared to the other areas (Fig. 3.13). Curve number 26 is one of the most critical curves among all. Similarly curve no 6 between km 159/2 to 161/1 in Katerniaghat WLS accounted regular animal mortalities. One or more than one curve has been noticed in all most all accident prone sections (Table 3.5 & 3.6).

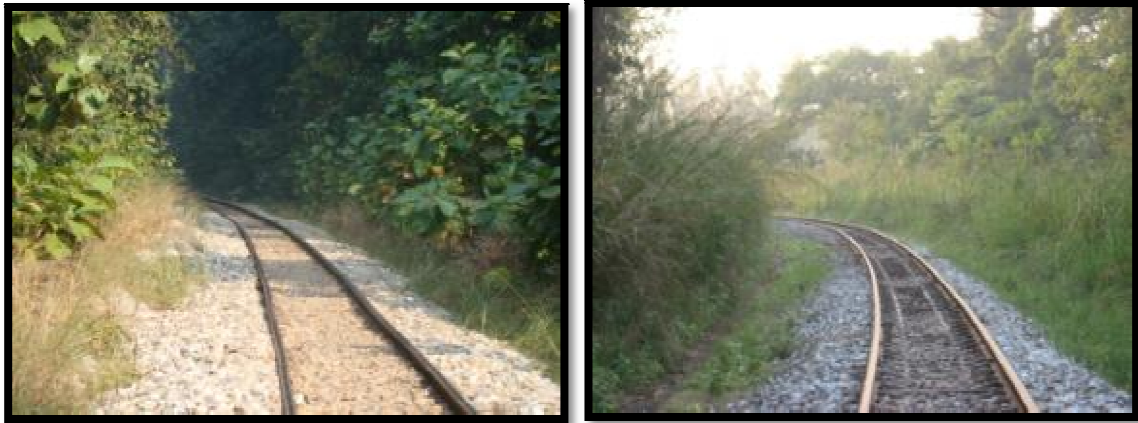
**Fig. 3.15 Growth of grasses and foliage decrease the visibility**

Visibility along the railway track especially on the curve is one of the important factors behind most accidents. During winter season due to thick fog visibility decreases drastically. In Dudhwa National Park and Katerniaghat Wildlife Sanctuary, 44% and 43% wildlife death due to train accidents respectively happened during winter season between months of November and February (Appendix 1 & Fig 3.2). Growth of grasses and thick foliage on the sides of the track further decreases the visibility and thereby increases the chances of accidents. In most of the accident prone areas visibility were found to be very low (Fig. 3.15, Table 3.5 & 3.6).

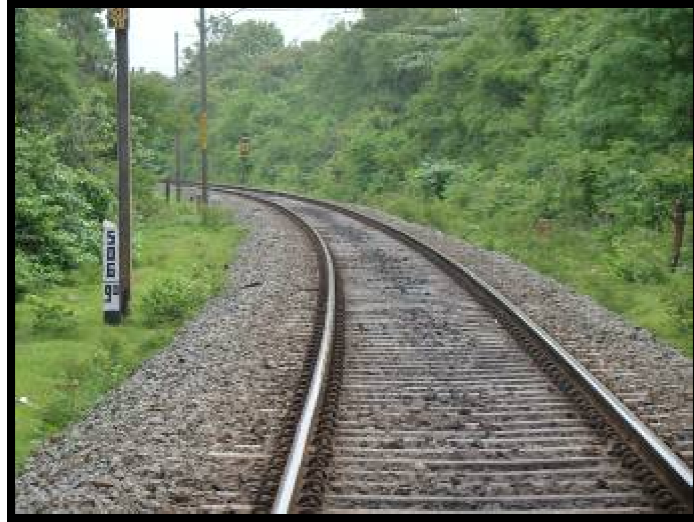
**Fig. 3.13: On sharp curve visibility decreases**

Curves are a very important physical feature along the track. Curves increase the probability of accidents due to low visibility (Fig. 3.13). The area between Walayar

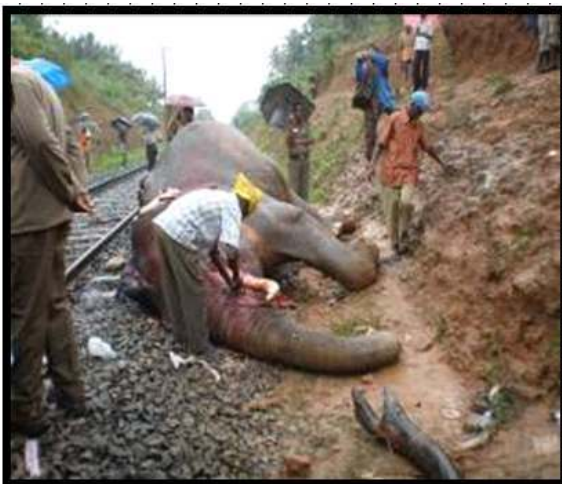
**Fig. 3.14: Elephant death in cutting between Etimadai and Walayar**

Cuttings are highly sensitive sections on the track. Animals get trapped in cuttings at the time of train movement and get killed. Out of nine accidents, six accidents have happened in cutting with steep embankments on the sides of the track Fig. 3.14, 3.15 & 3.16). In such a situation the animal does not get space to escape and cannot climb up to the top. The area between Walayar and Kanjikode specially on the B line has a large number of critical cuttings (Table 5, 6, 7 & 8 in Appendix-4). There are few critical cuttings between Walayar and Etimadai and Madukarai and Podanur (Table 6 & 8 in Appendix-4).

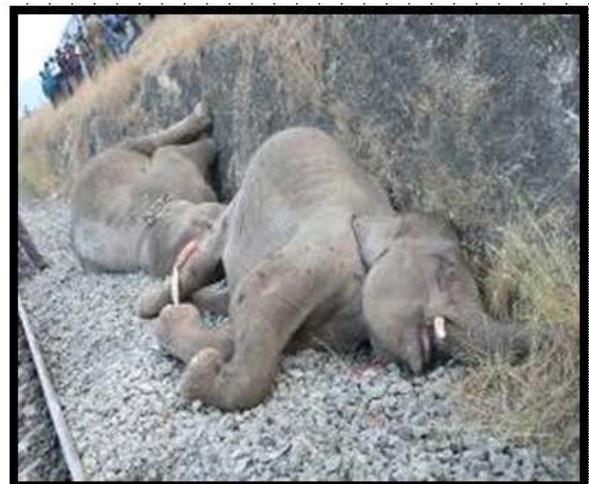
**Fig. 3.15: Elephant death in cutting Between Podanur and Madukkarai**

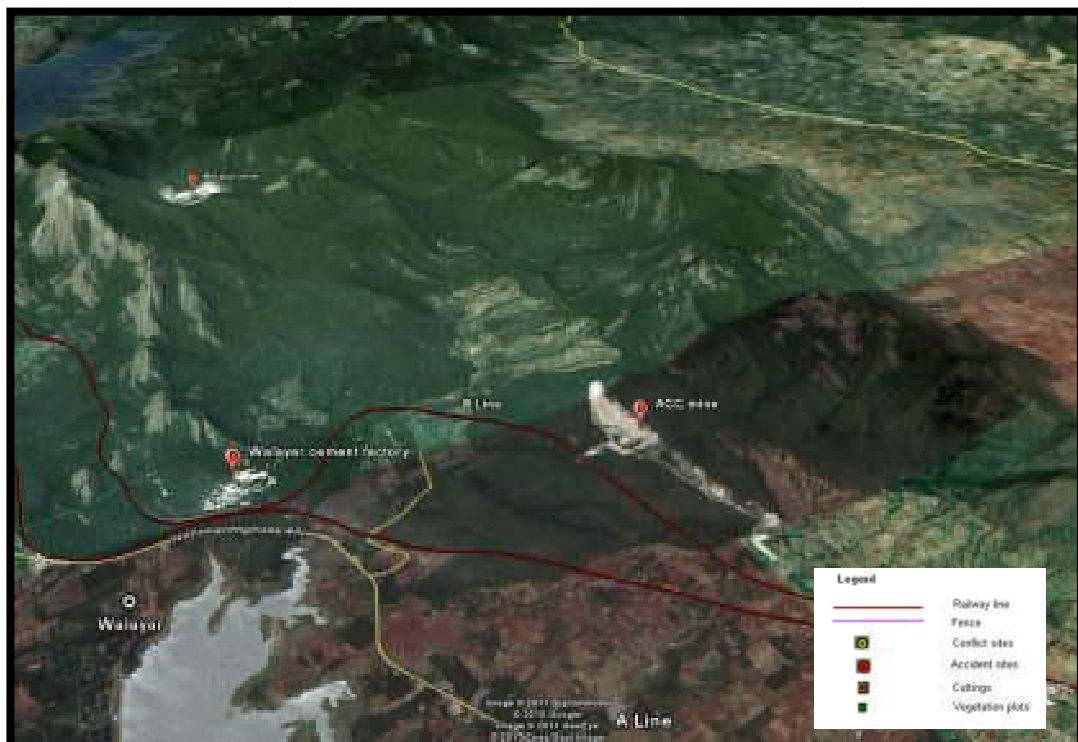
**Fig. 3.26: Map showing various disturbances to elephant movement**

Limestone mining activities in Walayar and Etimadai landscape is not only an obstruction in the elephant movement but also creates huge disturbances due to operation activities like, blasting, movement of heavy vehicle to carry ore and presence of operation staff (Fig. 3.24, 3.25, & 3.26). Similarly, indiscriminate building construction, industrial and urban development in the foothill between

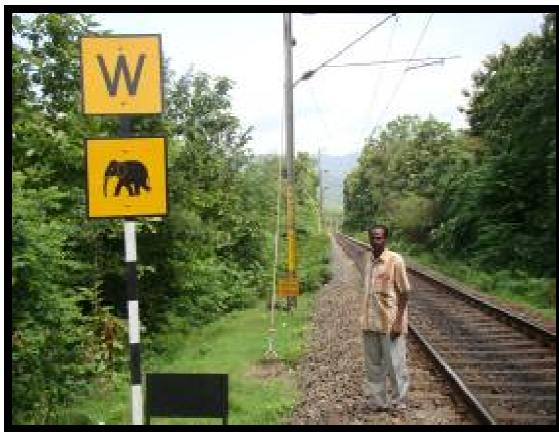
**Fig. 4.1: Elephant signage along the railway track**

The Railways has taken several initiatives to minimize the problem (Fig. 4.1 & 4.2). These include putting up elephant signage along the track to remind drivers about elephant movement, small awareness signage for the passengers on the railway stations, announcement for the train passengers at Palakkad and Coimbatore and patrolling of the track by their gang man. Other than this, the Railways has also issued a caution to their loco pilots to blow the whistle continuously in elephant movement areas and has reduced the train speed to 45 Km/ hour during night between 6 PM to 6 AM in the accident prone areas.

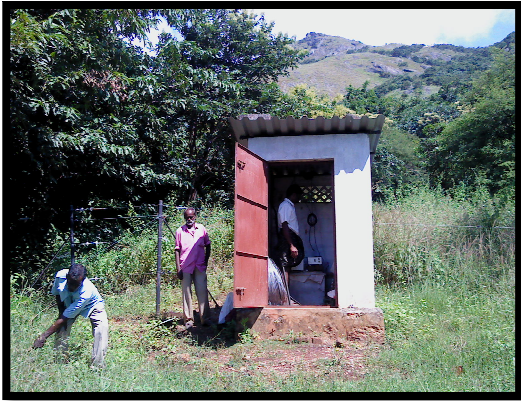
**Fig. 4.3: Power fence along the track**

The Kerala Forest Department has on its part fenced approximately 10 km of railway track between Walayar and Kanjikode in the Walayar range (Fig 4.3). Maintenance of these fences was found satisfactory except for a few sections. Similarly, Tamil Nadu Forest Department has also fenced some of the area before Podnair to restrict the elephant movement on to the road and railway track. However, these measures fall short of a comprehensive management plan which is required to stop the accidents from happening (Fig. 4.4). The selection of barrier for elephants should be done carefully as per the terrain and its maintenance (Fig. 4.5). Power fences may not be a long term solution due to maintenance problems.

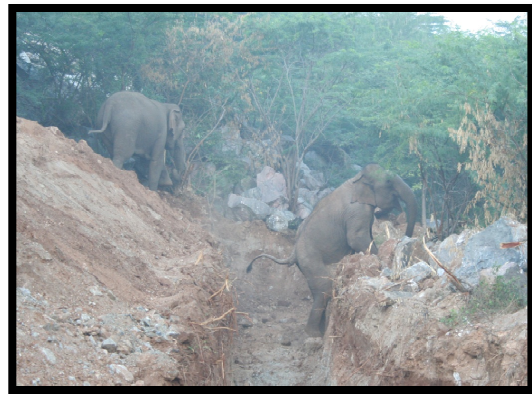
**Fig. 4.4: Elephant manages to cross the trenches**

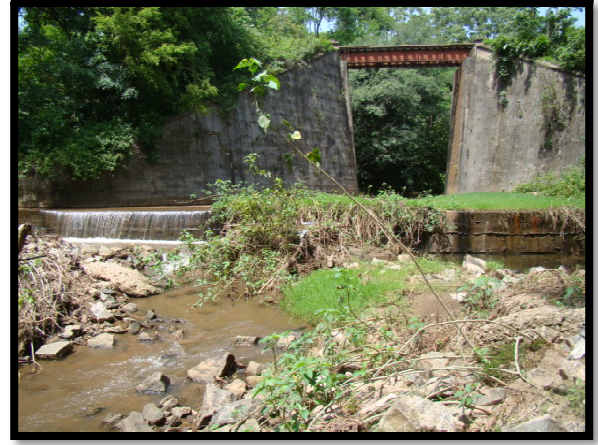
**Fig 5.2: Bridge which elephant can negotiate**

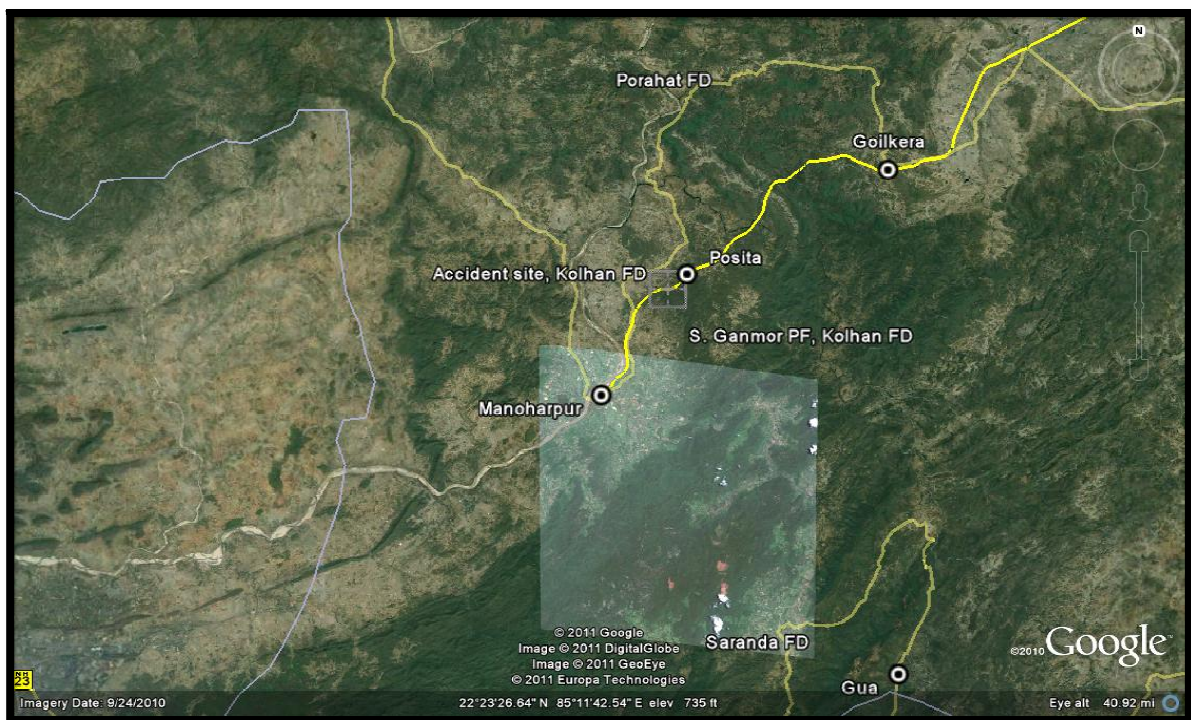
**Fig. 1.2 Accident prone railway sections in Kolhan Forest Division**

The five kilometer track section (Km 362 to 367) between Posotia and Manoharpur is the most critical section. On 7<sup>th</sup> August 2000, four elephants died in a single accident near Km 364/30. In the year 2001 again four elephants died in two accidents on 21<sup>st</sup> September (two) and 28<sup>th</sup> October (two) in the same area.

The railway track between Posotia and Manoharpur runs along the fringe of the forest of Kolhan FD (Fig. 1.2 & 3.4). Elephant movement in this section takes place mostly during crop season between August and February. Elephant movement from South Ganmore Protected Forest of Kolhan Forest Division, situated on south eastern side of the railway track usually takes place for crop raiding in the villages situated on the north western side of the railway track (Fig. 3.4). These villages are Sonpokhari, Barpose, Raida, Zozogutu, Ghaghera and posaita. After fencing, elephant crossing from south eastern side of the railway track has been stopped. Group size varied of elephants from 10 to 20 and on few occasion up to 35 elephants.

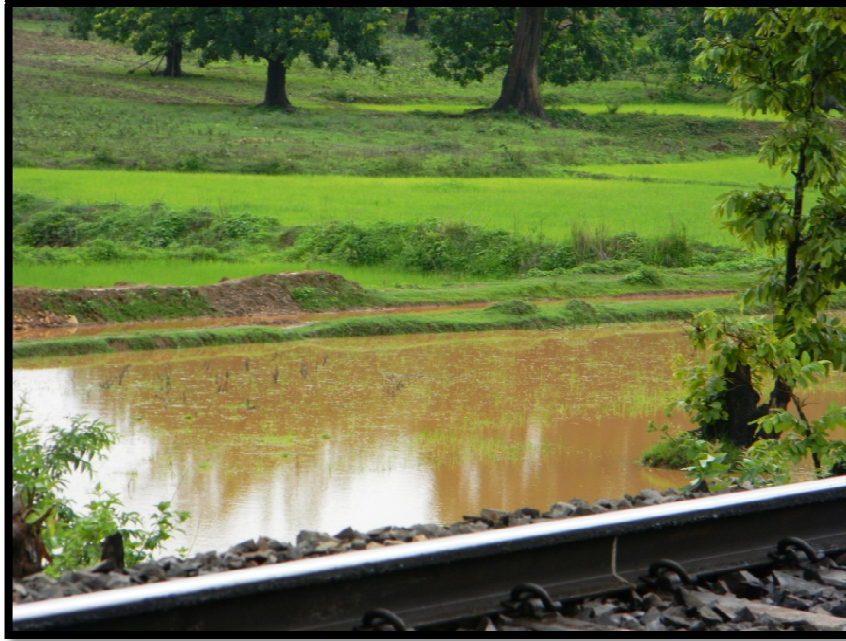
**Fig. 3.9 Crops near railway track is one of the major attractant for elephant.**

Agriculture activity in close vicinity of railway track has been a major attractants for the wild animals. All accidents prone sites in Jharkhand have presence of crop field in close vicinity (Fig. 3.9). In Saraikela- Kharsama Forest Division, cropland of Kandra and Raghunathpur villages are situated close to the track. Similarly in Kolhan Forest Division elephant raid crops in Posotia, Ganmore, Zozoguta, Sanpokhari, Raida, Baressa, Dhipa, Ghaghra and Tumsai villages.

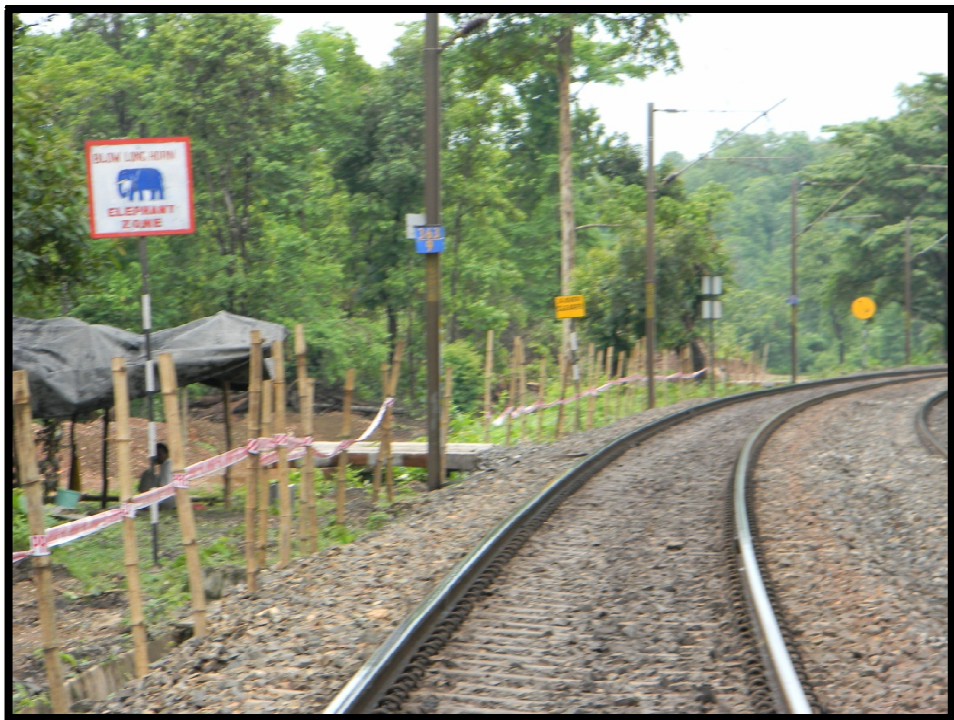
**Fig. 3.12 Caution signage along the railway track in accident prone area between Posotia and Manoharpur section in Kolhan FD**

- Signage has been also installed along the railway track in elephant movement areas (Fig. 3.12).

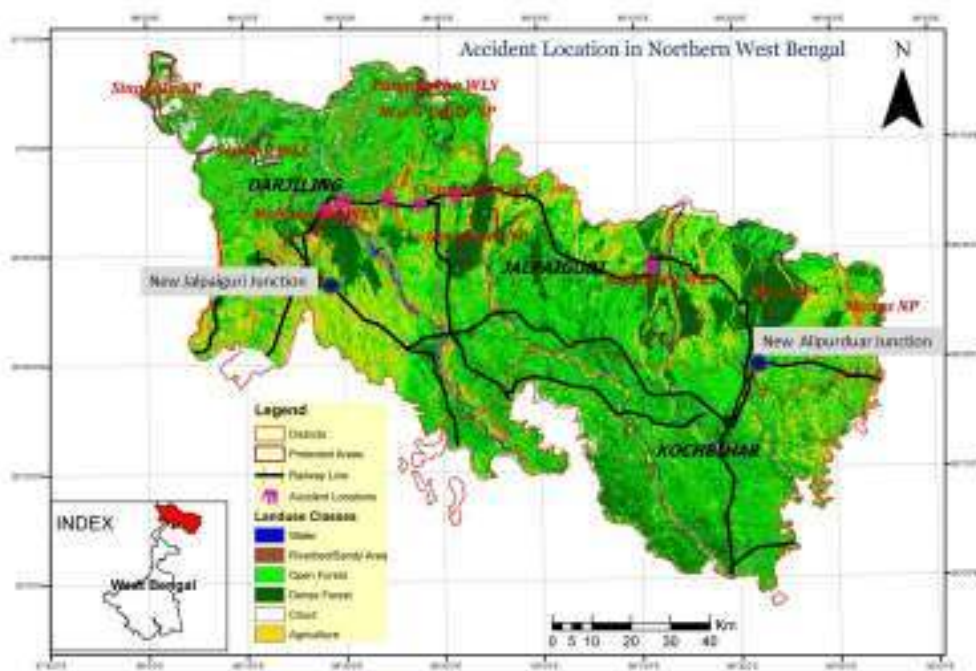
Fig. 3.2 Locations of the elephant deaths on the railway track in North Bengal

Till date 49 elephants have been killed in different sections of this railway track (Fig 3.2). Most of the elephant deaths have happened in Mahananda WLS (12), Chapramari WLS (9), Jalpaiguri Wildlife Division (9), Buxa Tiger Reserve (7), Kalingpong Forest Division (5) and Jaldapara WLS (4) contributing to 94% of the elephant deaths due to train accidents in the state (Fig 3.3).
