MINIMISING DISTURBANCE TO WILDLIFE IN ANAMALAI TIGER RESERVE DUE TO CONTOUR CANAL REPAIR AND CREATION OF WILDLIFE CROSSINGS

Main facts and requested action by Standing Committee NBWL

Photographs of Contour Canal in Anamalai Tiger Reserve and ongoing work

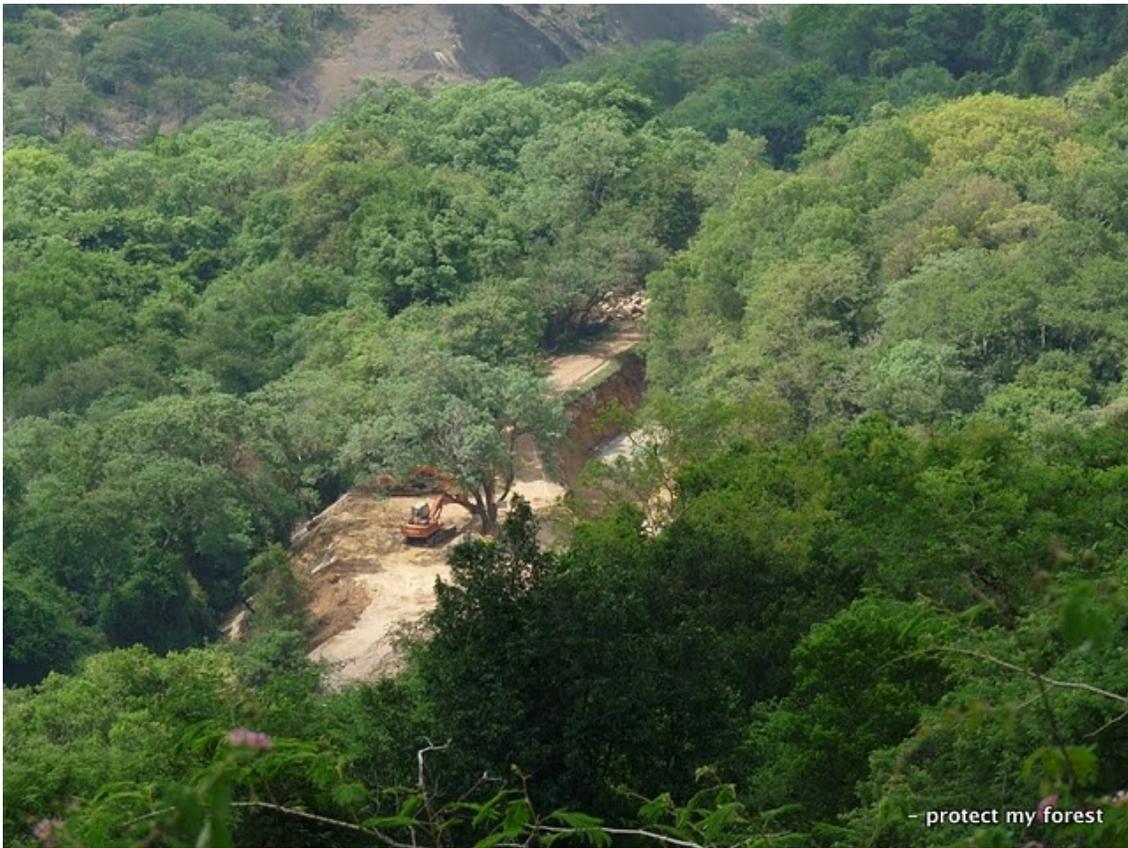
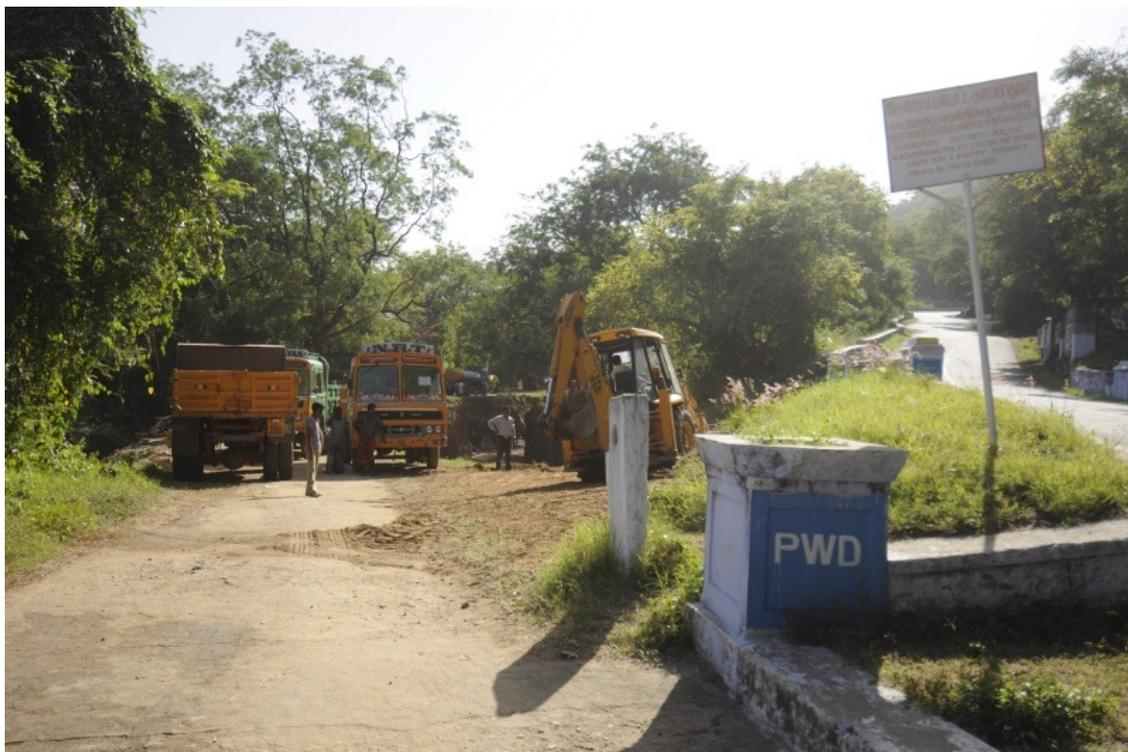
Movements of heavy machinery along Contour Canal in Anamalai Tiger Reserve

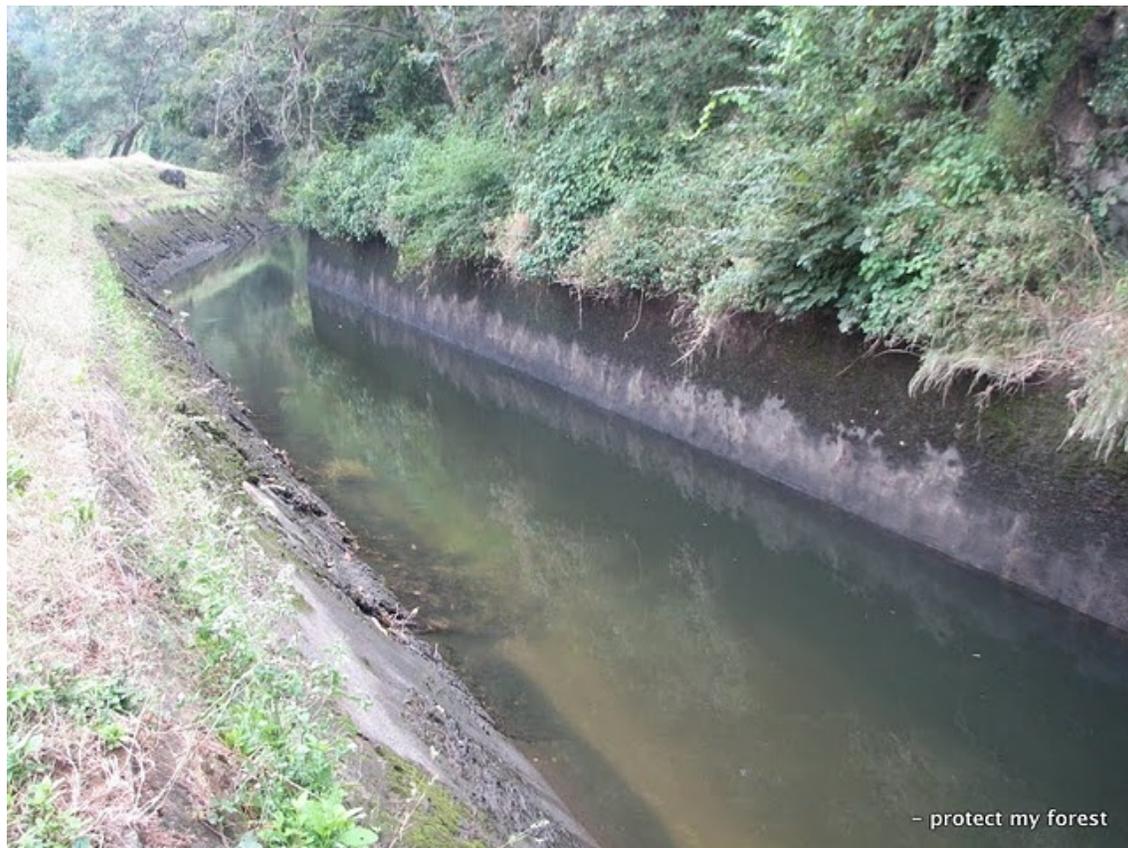
Where the steep-sided canal passes through ATR, many animals get drowned/washed away and wildlife crossing is hindered due to unsuitable design and very few structures to allow animal crossings.

- The canal begins near Sarkarpathy powerhouse, in the Pollachi range of ATR and ends at Thirumurthy reservoir located in the fringes of the Udumalpet range of ATR.
- Near Thirumurthy reservoir, the canal extends outside the Tiger Reserve for about 8 km. The rest of the length of the canal is within the Tiger Reserve.
- The canal is steep and the forest is precipitous near the bank where animals are vulnerable to fall into the canal and cannot swim back safely due to its slippery cement banks. The banks are un-scalable.

Photograph showing steep sides of Contour Canal that poses hazards to wildlife

- (a) permissions and conditions for undertaking such repair work,
- (b) design considerations and wildlife crossing structures where canal runs within ATR,
- (c) initiate an awareness campaign on watershed and ecosystem service benefits of ATR and on minimising negative effects of canal on forests and wildlife in ATR.

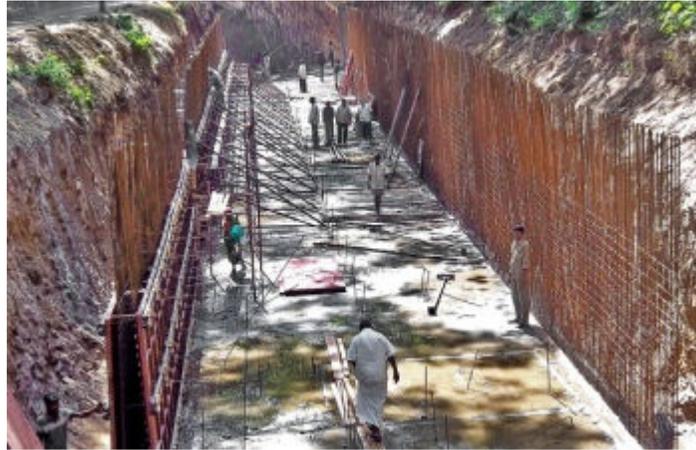
Fast pace: Work under way for renovating the 49.3 km long contour canal from Sircarpathy to Thirumurthy dam of the Parambikulam - Aliyar Project.
