1st INTERIME REPORT

BULK WASTE GENERATORS

**4 SUB- COMMITTEES CONSTITUED PURSUANT THE
ORDERS OF HON'BLE NGT IN THE MATTER OF
199/2014 & 281/2016**

Interim Report of the Sub-Committee-1 **For New Delhi Municipal Council area**

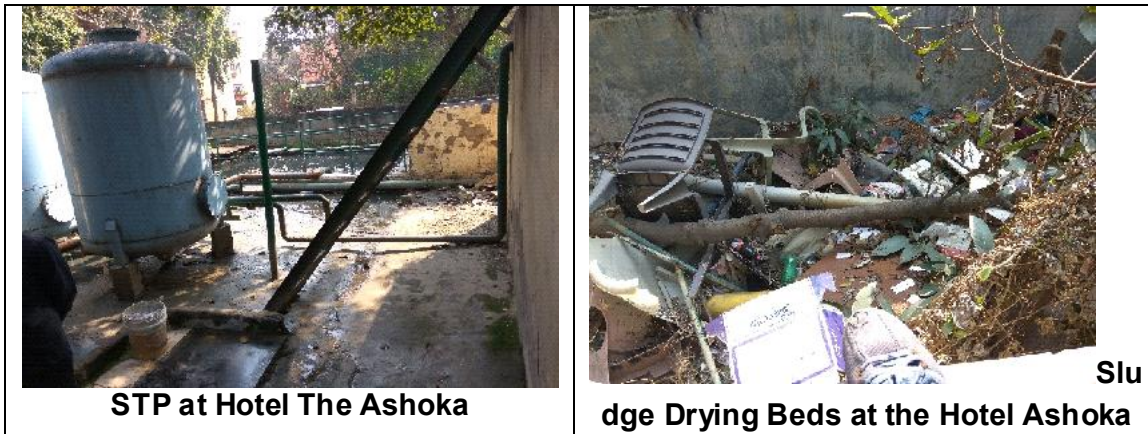
(iii) Ashoka & Samrat Hotel- The committee inspected the Ashoka Hotel and found that their STP is very old. The operation of the STP was not to the desired standard due to foully smell and overflowing of sewage in the plant premises. This was also indicated in the effluent samples analyzed by Central Pollution Control Board (CPCB) where BOD was found 51 mg/l, higher than the prescribed standards. The Hotel Management was suggested to take remedial action at the earliest for retrofitting/ augmentation of the existing STP. There was no provision observed for sludge management at STP premises and the sludge drying bed was full with discarded materials. The sewage/ wastewater was spreading all over the STP units which causes mosquito spreading also.

It is also pertinent to mention here that the sewage from Hotel Samrat was also being brought to same STP established in the premises of Ashoka hotel. The sewage generated from Ashoka and Samrat hotels is treated in common STP. There was also a common laundry of Ashoka hotel and Samrat hotel. The laundry liquid waste also goes to STP for further treatment. It was observed that RO rejects were also found to be pumped into ineffective STP. This partially treated sewage is ultimately discharged into the NDMC sewerage system, thus increasing the load on the STP at Okhla.

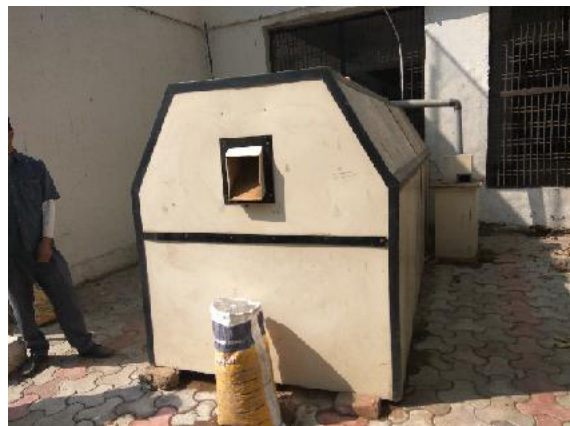
- The Organic Waste Convertor (OWC) was installed in the premises and functional.
- The wet waste was collected and stored in the designated place within the premises. The dry waste was outsourced to an agency for collection and further recycling and reuse.
- The waste disposal process followed by the outsourced agency is not known to the hotel management.

- RWH system was in place and not working. It was suggested to clean the filter pre and post monsoon.

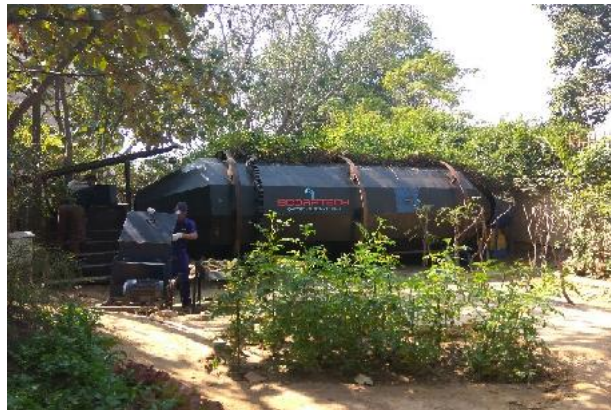
- The Organic Waste Converter (OWC) was installed and functional in the premises. The capacity of the OWC plant was 500 kg/day. The wet waste was collected and stored in the designated place within the hotel premises

for producing compost using OWC. The compost produced was utilized in their horticulture.
